TEST REPORT # **T1003-1**

TESTING REQUESTED: **Testing to the flaming and penetration requirements of the following criteria: ASTM E119-14, Standard Test Methods for Fire Tests of Building Construction and Materials, and CAN/ULC S101-07, Standard Methods of Fire Endurance Tests of Building Construction and Materials. See page 6 for deviations from the test standard.**

TESTED RATING: 15-Minute Fire Resistance

This report documents the fire testing conducted by QAI Laboratories Ltd. for Fire Retardant Coatings of Texas of a FX Lumber Guard XT treated 3/8 in. thick OSB wall assembly. Testing was performed in accordance with ASTM E119-14, Standard Test Methods for Fire Tests of Building Construction and Materials, and CAN/ULC S101-07, Standard Methods of Fire Endurance Tests of Building Construction and Materials, with the deviations found on page 6. The wall was evaluated for a 15-Minute Fire Resistance rating on April 24, 2015.

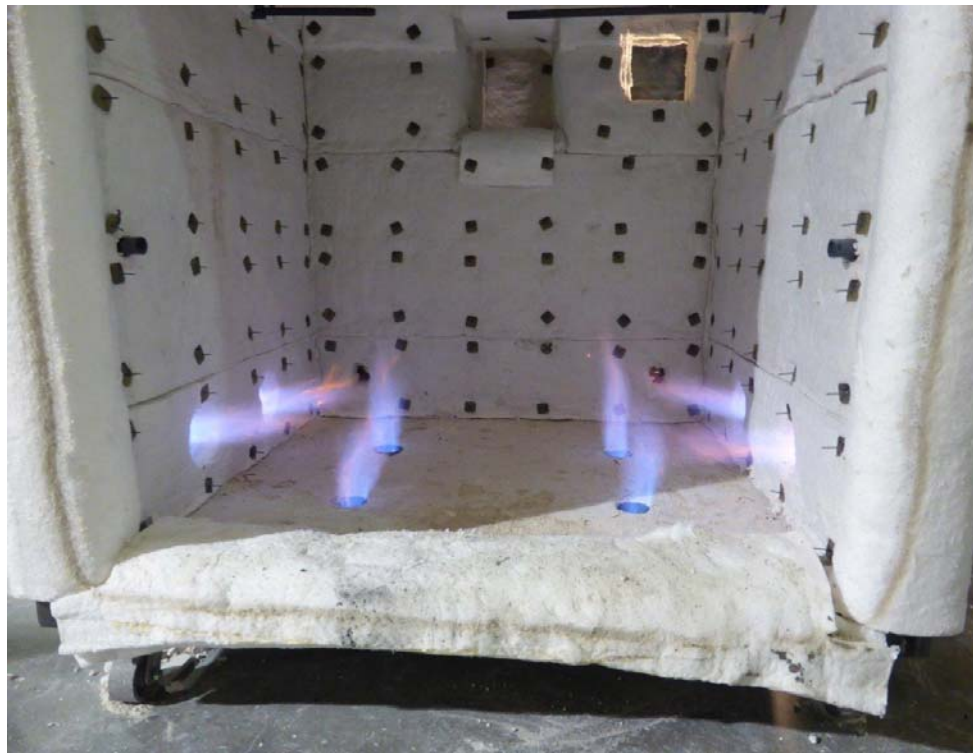
Figure 1: Burners Fired in the Furnace

Temperatures within the furnace were monitored using four thermocouples. The temperatures are controlled by adjusting fuel to the furnace burners to conform to the time/temperature curve specified by the test standards. Temperature measurements are recorded by a Keithley 2750 data acquisition unit (ID# DMM1) which passes the readings to a computer for graphical display and storage.

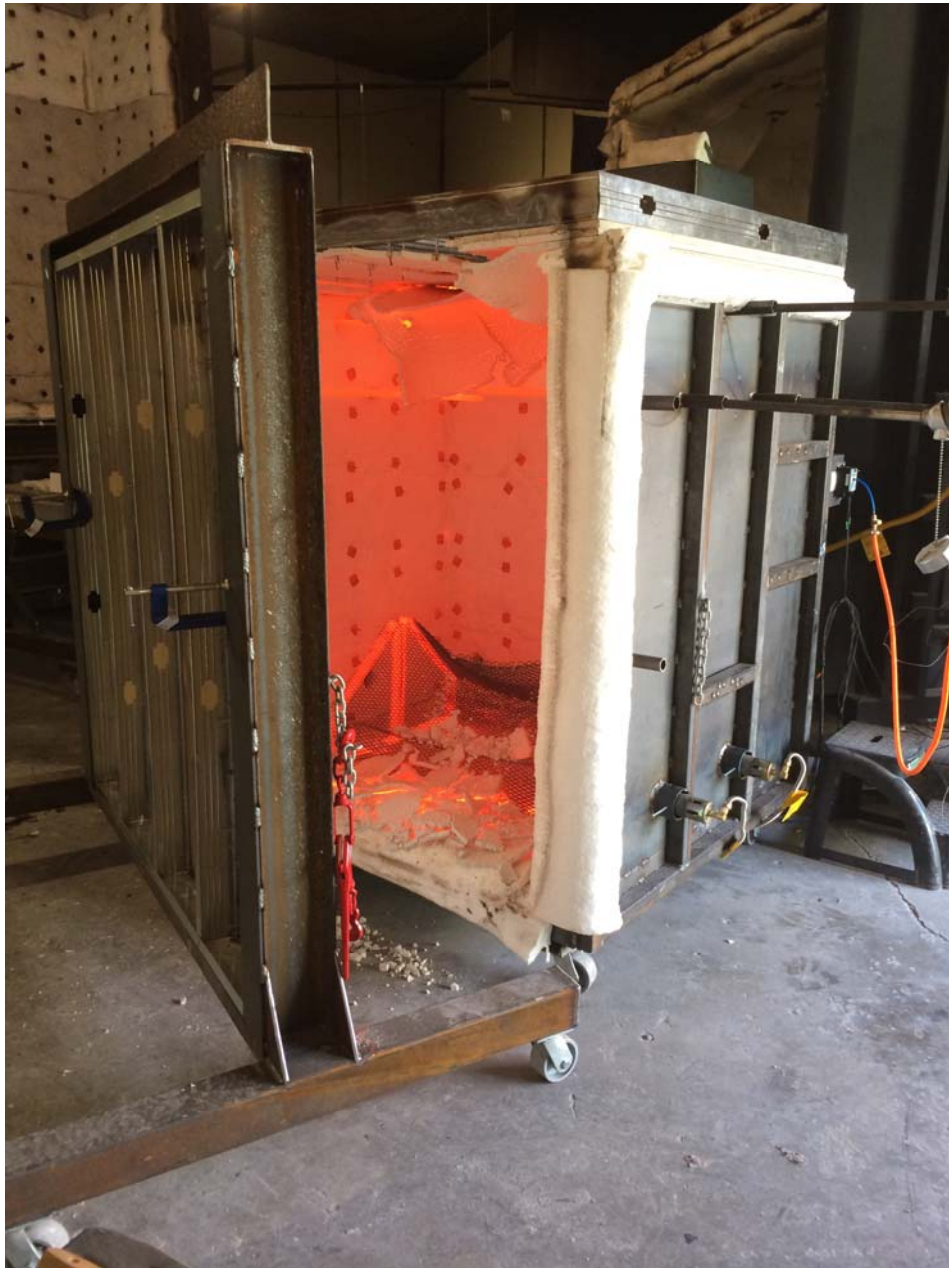
Figure 2: Pilot-Scale Furnace

The furnace used in the tests is a pilot-scale fire burning apparatus with interior dimensions of 60 in. in height, 60 in. in width, and 52 in. in depth.

The wall assembly was mounted in a vertical orientation, into a steel frame specimen holder. The specimen holder was then rolled up to the furnace and secured by chain to the furnace opening. At the end of the tests the specimen holder was rolled away from the furnace so that the exposed face can be extinguished.

One pressure tap was installed through the back of the furnace. The pressure tap was attached and monitored by Setra model 264 pressure transducers (ID# Pressure T3). The furnace pressure is controlled by adjusting a damper in the furnace exhaust stack and air flow into the furnace to maintain the neutral pressure plane.

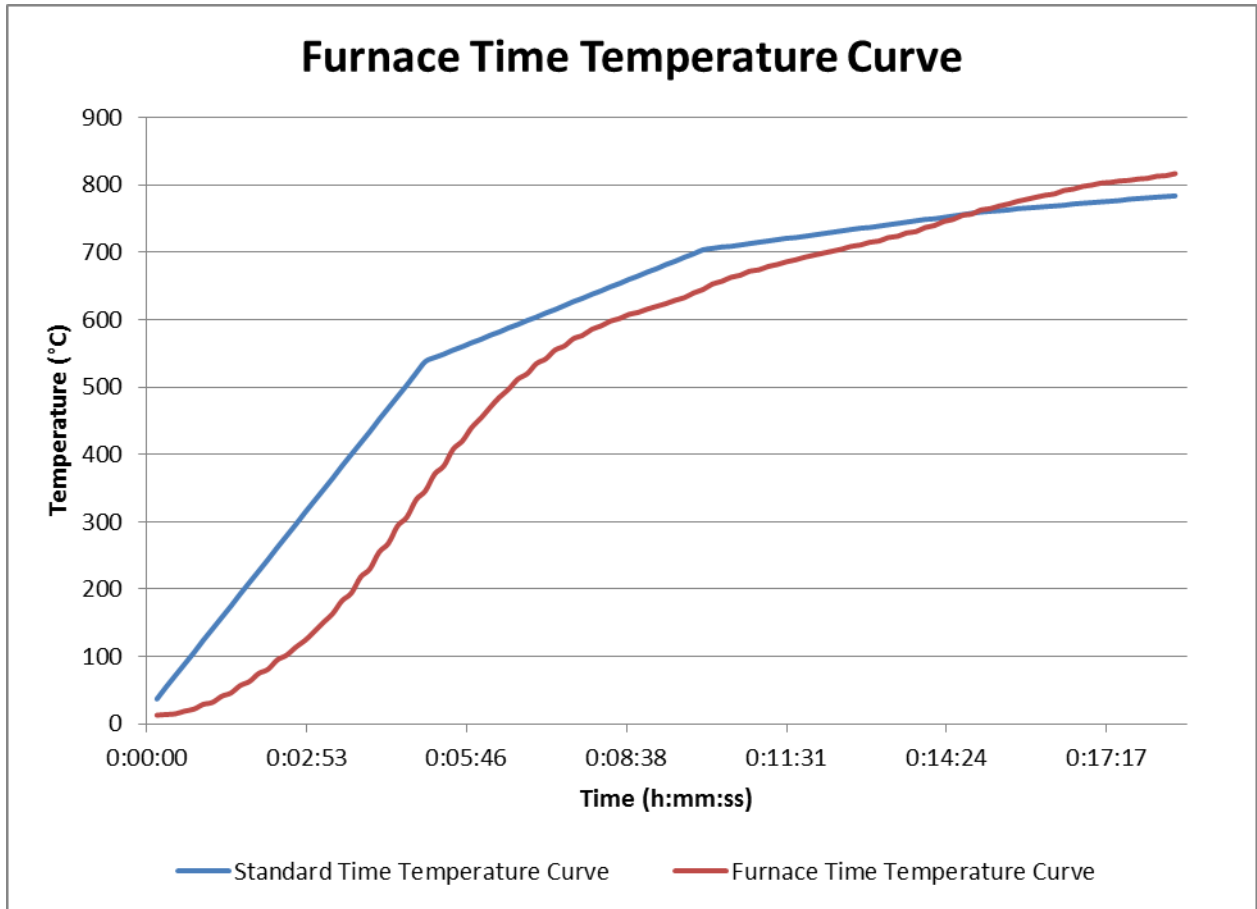
Figure 3: Time Temperature Curve

Prior to the fire endurance test the test assembly was moved into position in front of the furnace opening and the pilot burners were ignited. The fire endurance test was initiated after igniting the burners. The temperature inside the furnace was controlled to follow the standard time/temperature curve within the limits described in the test standards.

A penetration through the surface of the OSB occurred at 18 minutes 32 seconds into the fire test. This duration was corrected using the equation in section 5.2.6 of CAN/ULC S101-07 and section 9.4 of ASTM E119-14. The corrected duration based on the area of the time temperature curves is 16 minutes 22 seconds.

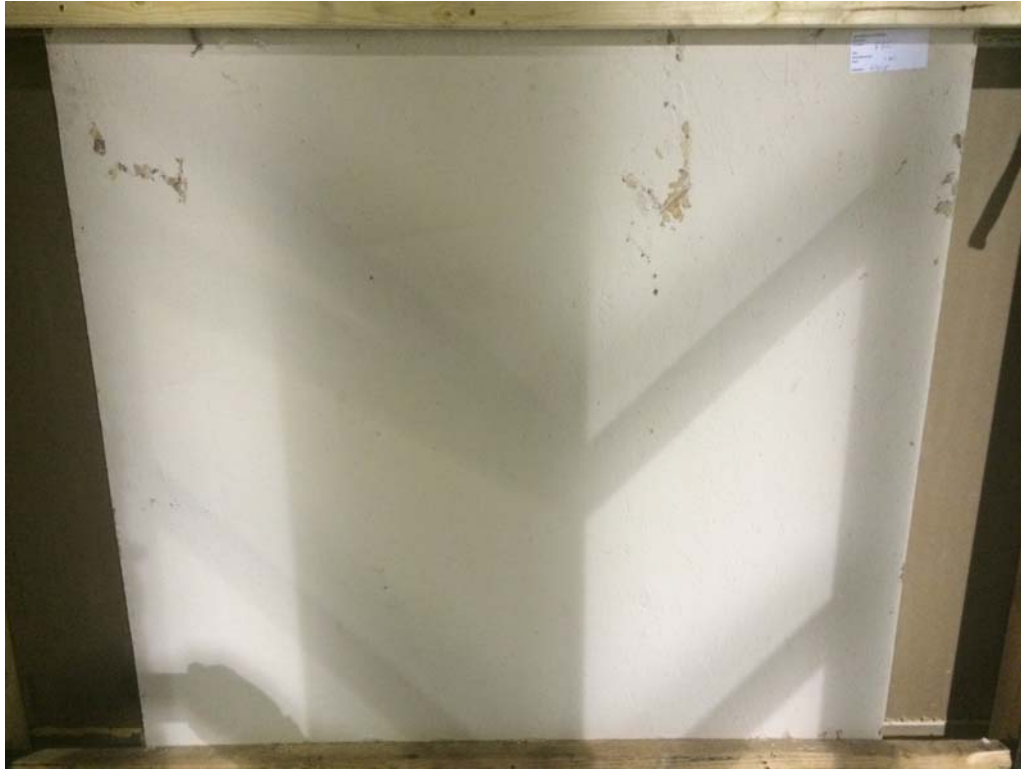
Figure 4: Unexposed Side Prior to Test

Wall Construction:	Type:	Fire retardant coated OSB wall assembly.
	Overall Size:	48 in. wide by 48 in. high by 3-7/8 in. thick.
	Framing:	Nominal 2x4 in. wood studs spaced 12 in. on center.
	Sheathing:	3/8 in. thick OSB.
	FR Coating:	FX Lumber Guard XT applied to the interior of the panel in one application at a rate of 300 to 350 sq.ft./gallon.
	Fasteners:	1-5/8 in. coarse thread drywall screws spaced approx. 10 in. on center.

The Fire Retardant Coatings of Texas wall assembly was constructed in a pilot-scale moveable steel test frame. The perimeter of the test sample was protected with wood studs and 5/8 in. thick type X gypsum board. The space between the test frame and the wall assembly was filled with ceramic fiber batt to prevent air movement between the frame and wall.

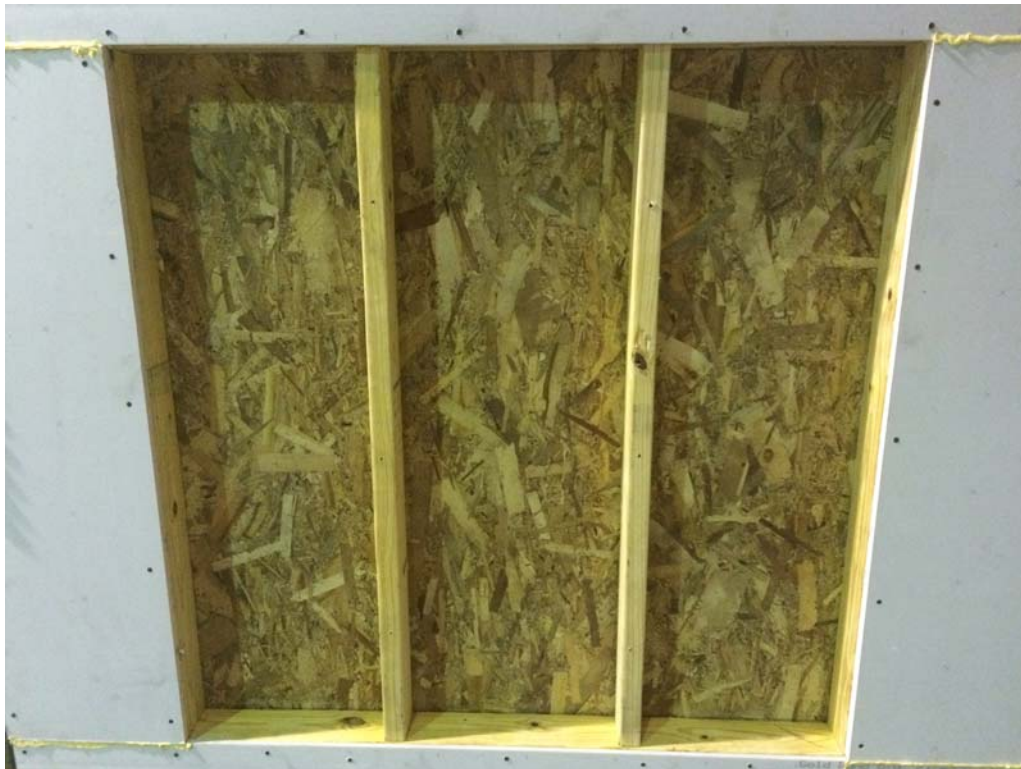
Figure 5: Exposed Side Prior to Test

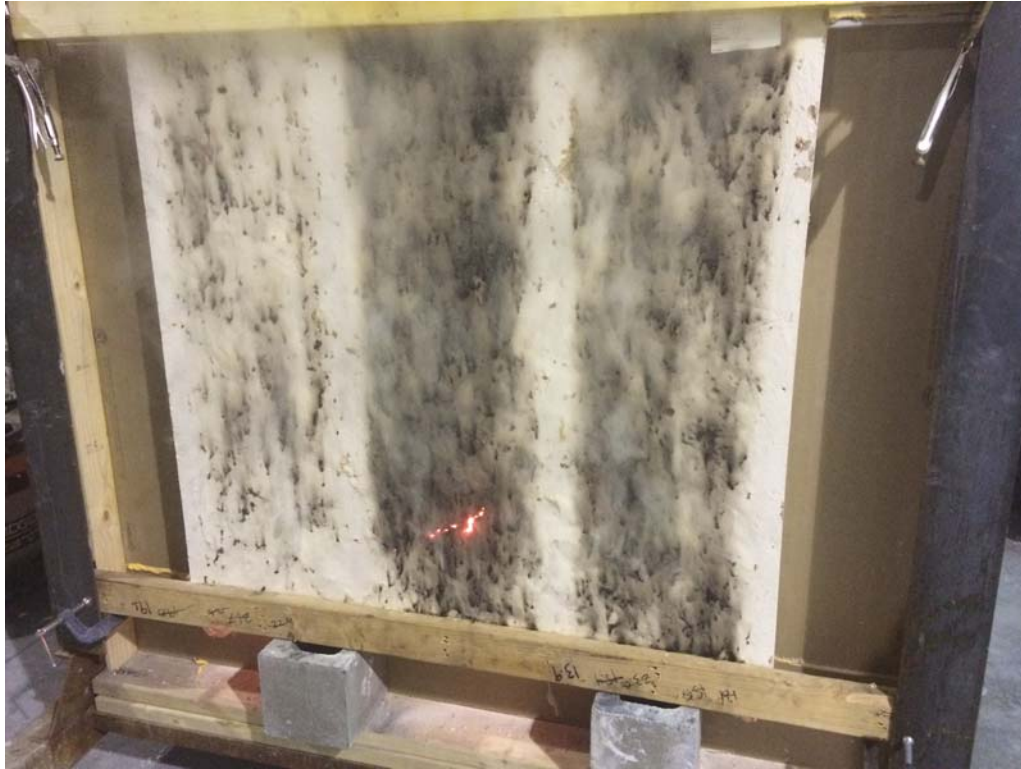
Figure 6: Unexposed Side at Termination of Fire Exposure

Test Time (min)	Unexposed	Exposed
1:30		The intumescent is beginning to react.
2:20		The surface of the OSB appears to be white in colour.
3:00		The 2x4's are black, the OSB is beginning to darken.
4:13		Entire assembly is black.
5:30	The paint is blistering.	No surface flaming.
7:10	Venting from the surface.	
17:40	Darkening of the surface between the studs.	
18:32	Burn through, test discontinued.
